Vascular and Interventional Radiology Case report

Inadvertent cannulation of subclavian artery in central venous catheter insertion: A case report and review of prevention and management

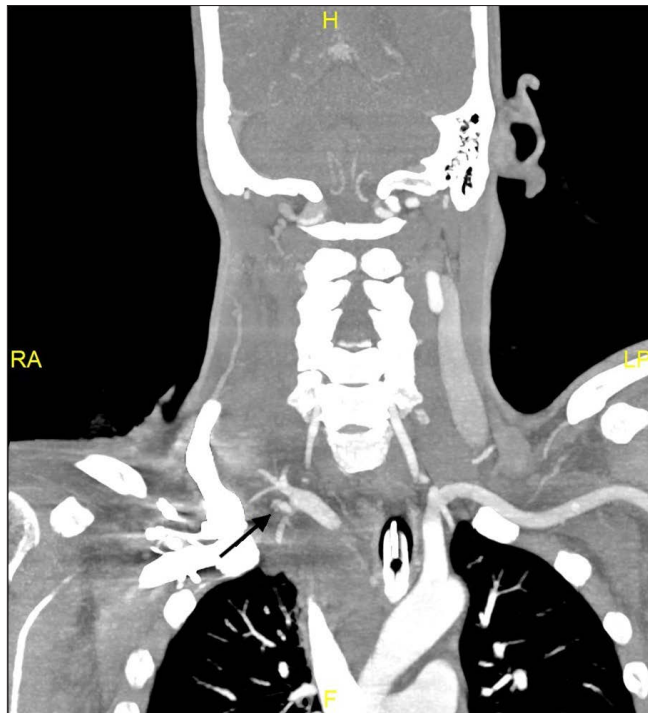
Figure 1b: 40-year-old man with suspected arterial injury after central venous catheter insertion. (b) CT angiogram (coronal) of the neck showed contrast extravasation (arrow) at the junction between the right subclavian artery and internal mammary artery.

An arterial injury was suspected as bright red blood was aspirated when the operator inserted the catheter. The central venous catheter was immediately removed for hemostasis by external compression. CT angiogram of the neck showed contrast extravasation at the junction between the right subclavian artery and internal mammary artery. The endovascular approach to repair the arterial injury was chosen due to difficult surgical access [Figure 1a-c].

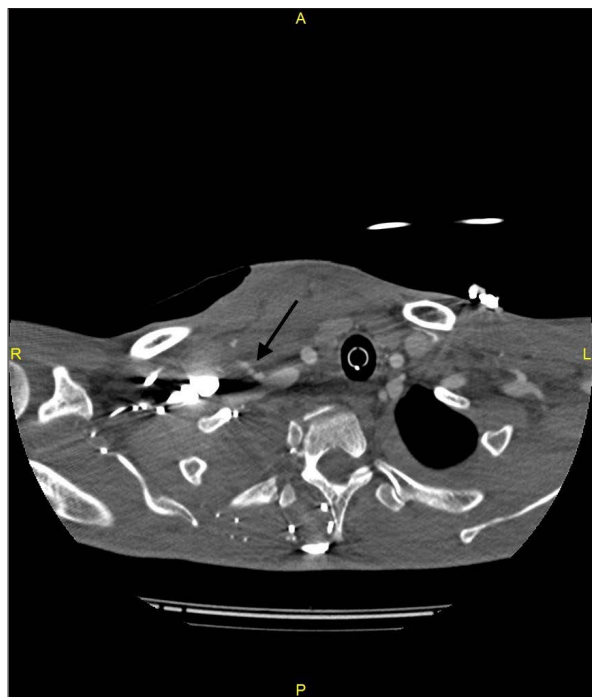
Figure 1a: 40-year-old man with suspected arterial injury after central venous catheter insertion. (a) CT angiogram (axial) of the neck showed contrast extravasation (arrow) at the junction between the right subclavian artery and internal mammary artery.

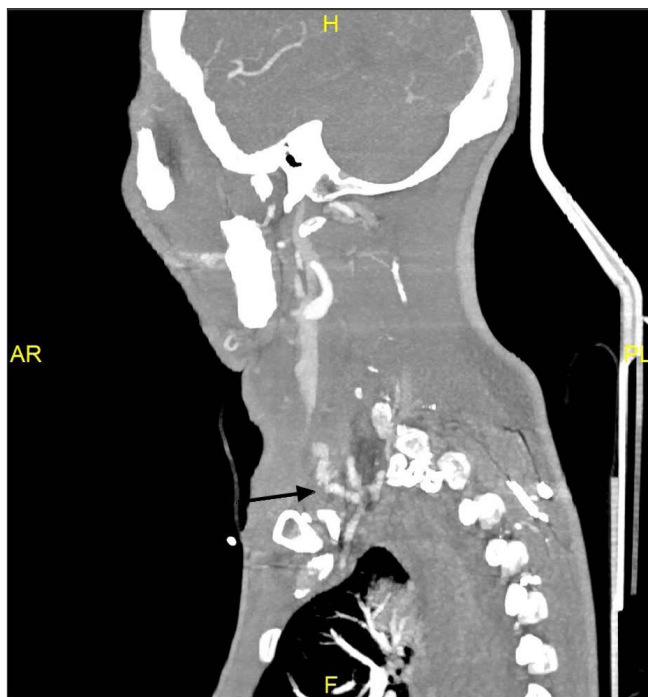
Figure 1c: 40-year-old man with suspected arterial injury after central venous catheter insertion. (c) CT angiogram (sagittal) of the neck showed contrast extravasation (arrow) at the junction between the right subclavian artery and internal mammary artery.

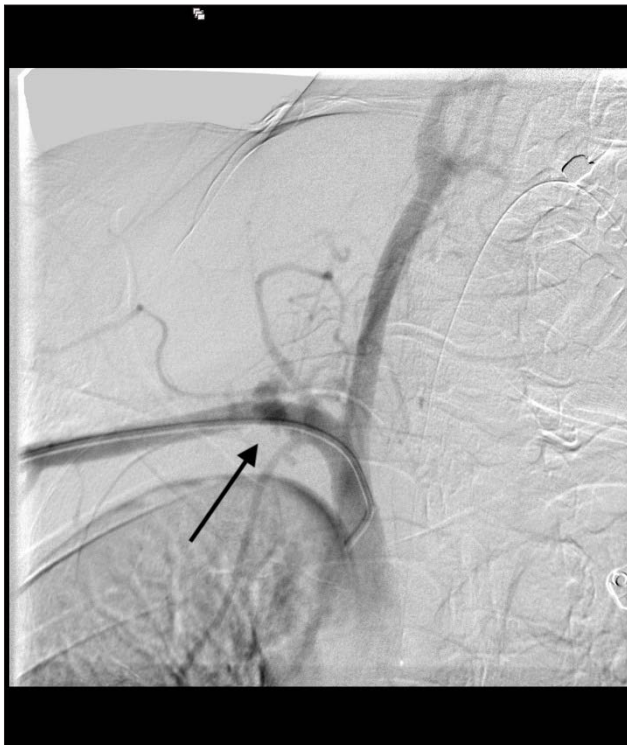
Figure 2a: Digital subtracted imaging (DSA) of the right subclavian artery. The right internal mammary artery was sacrificed with coil embolisation before right subclavian artery reconstruction. (a) DSA shows contrast extravasation (arrow) at the junction between the right subclavian artery and internal mammary artery

Digital subtracted imaging (DSA) of the right subclavian artery was performed using the right brachial approach. After a 5Fr arterial sheath (Terumo, Tokyo, Japan) was inserted, the right subclavian artery was cannulated with a C1 catheter (Cook Medical, Bloomington, Indiana). DSA showed contrast extravasation at the junction between the right subclavian artery and the internal mammary artery [Figure 2a]. In view of the proximity between the internal mammary artery and the site of injury, the right internal mammary artery was embolized before placing a covered stent in the right subclavian artery. Coil embolization of the right internal mammary artery was performed using Nestor (Cook Medical, Bloomington, Indiana) and Interlock coils (Boston Scientific, Marlborough, Massachusetts) through a 2.5Fr Renegade microcatheter (Boston Scientific, Marlborough, Massachusetts).

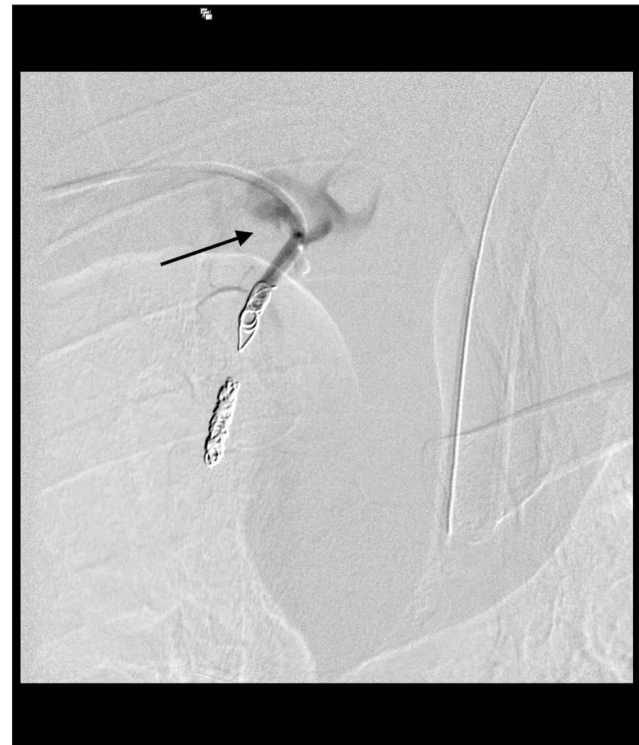
Figure 2b: Digital subtracted imaging (DSA) of the right subclavian artery. The right internal mammary artery was sacrificed with coil embolisation before right subclavian artery reconstruction. (b) DSA of the right internal mammary artery after embolisation shows no distal flow but contrast extravasation (arrow) from the proximal internal mammary artery.

Post embolization DSA of the right internal mammary artery showed no distal flow but persistent contrast extravasation

from the proximal internal mammary artery [Figure 2b]. A stent graft was placed in the right subclavian artery to reconstruct the vessel. The origin of the right vertebral artery was included in the landing zone of the covered stent. However, in view of the right vertebral artery being non-dominant and it was a lifesaving procedure, the right vertebral artery was sacrificed. A Begraft (Bentley Innomed, Hechingen, Germany) peripheral stent (9 mm x 3.7 cm) was chosen. A 7Fr arterial sheath (Terumo, Tokyo, Japan) was exchanged at the right brachial artery. Deployment of the covered stent was then performed with the aid of a pressure inflator. The proximal end of the stent was deployed distal to the origin of the right subclavian artery while the distal end was deployed distal to the origin of the right thyrocervical trunk [Figure 3a]. Mild contrast extravasation was noted after the stent deployment and balloon angioplasty was performed using a 10 mm Mustang balloon (Boston Scientific, Marlborough, Massachusetts) [Figure 3b-c]. Post-procedure DSA showed no contrast extravasation at the right subclavian artery [Figure 3d].

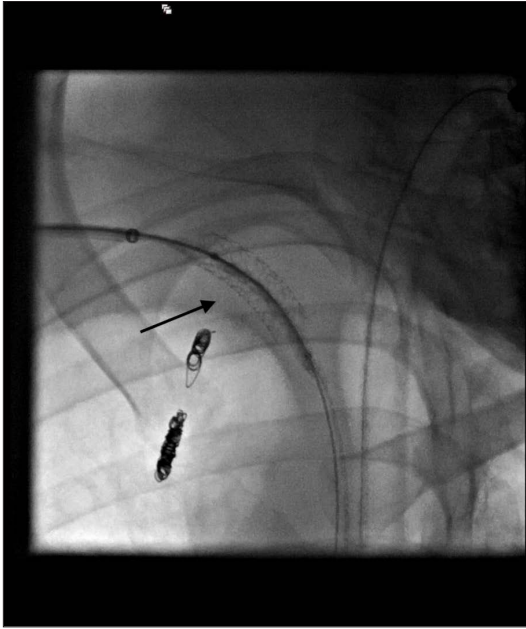
Figure 3a: 40-year-old man with right subclavian artery injury after central venous catheter insertion. A peripheral stent graft is deployed in right subclavian artery after right internal mammary artery embolization. (a) A Begraft peripheral stent (arrow) was deployed in right subclavian artery.

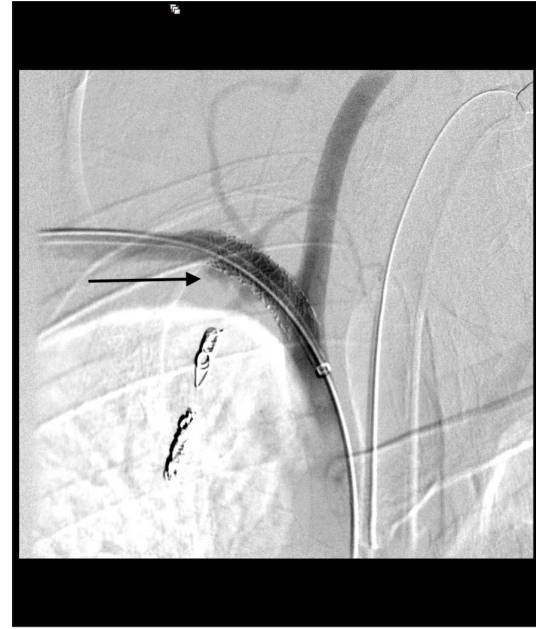
Figure 3b: 40-year-old man with right subclavian artery injury after central venous catheter insertion. A peripheral stent graft is deployed in right subclavian artery after right internal mammary artery embolization. (b) DSA of right subclavian artery shows persistent contrast extravasation (arrow) after the stent deployment.

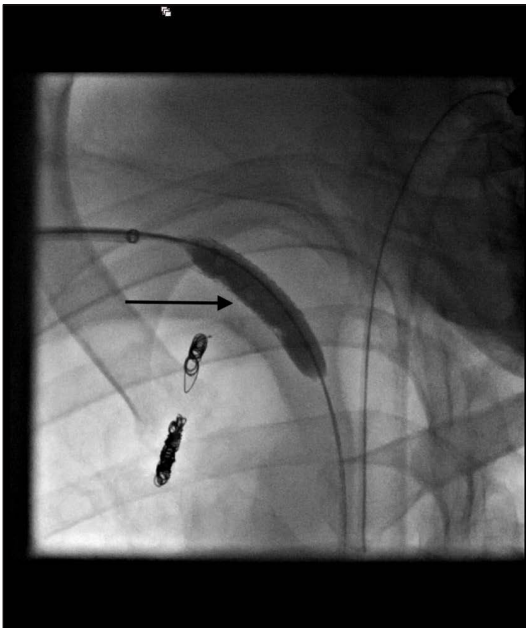
Figure 3c: 40-year-old man with right subclavian artery injury after central venous catheter insertion. A peripheral stent graft is deployed in right subclavian artery after right internal mammary artery embolization. (c) Balloon angioplasty was performed using a 10 mm Mustang balloon (arrow)

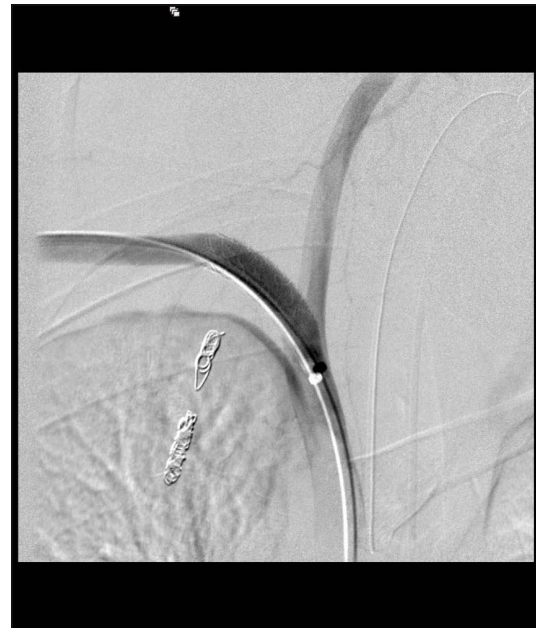
Figure 3d: 40-year-old man with right subclavian artery injury after central venous catheter insertion. A peripheral stent graft is deployed in right subclavian artery after right internal mammary artery embolization. (d) Post balloon angioplasty DSA of right subclavian artery showed no further contrast extravasation.
