Education Imaging science

Radiofrequency interference in magnetic resonance imaging: Identification and rectification

Wingchi Edmund Kwok¹

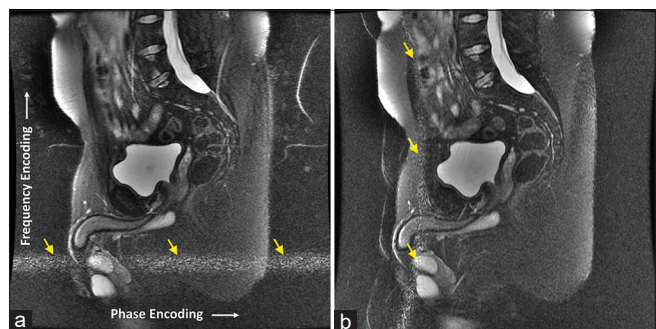
Figure 1: (a) Abdomen magnetic resonance (MR) image with radiofrequency interference artifact (labeled by yellow arrows) caused by damaged shielding in the MR scanner room door. (b) The direction of the artifact (labeled by yellow arrows) changed with the swapping of frequency and phase encoding directions in the image acquisition.

RF interference artifact usually appears as bright parallel lines or bands resembling zippers along the phase encoding direction of an image [Figure 1a]. The positions of the individual artifact lines/bands in the frequency encoding direction correspond to the frequency components of the interfering RF field. If the frequency and phase encoding directions are swapped, the orientation of the artifacts in the image changes accordingly [Figure 1b]. If the RF interference is very broadband,^[6] the artifact is manifested as increased background noise, resulting in lower image signal-to-noise ratio (SNR) [Table 1] and lower image quality [Table 2]. RF interference artifact can mimic pathologies and obstruct the viewing of underlying tissues, affecting diagnostic evaluation and may even cause the image to be non-diagnostic in severe cases.

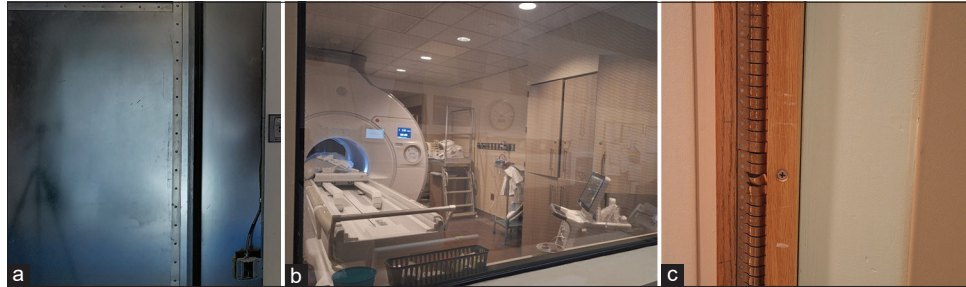
Figure 2: Photographs of (a) wall shielding, (b) screened window shielding, and (c) door shielding in the magnetic resonance scanner room.

To prevent unwanted RF field from entering the MR scanner room, it is necessary to install RF shielding [Table 1] that covers the entire room including all walls, ceiling, floor, window, and door^[10] [Figure 2a-c]. RF shielding usually consists of copper, steel, or aluminum panels/sheets.^[10] The typical shielding requirement is 100 decibels (dB) attenuation at 100 MHz for 1.5 Tesla (T) and 100 dB attenuation at 150–170 MHz for 3.0 T.

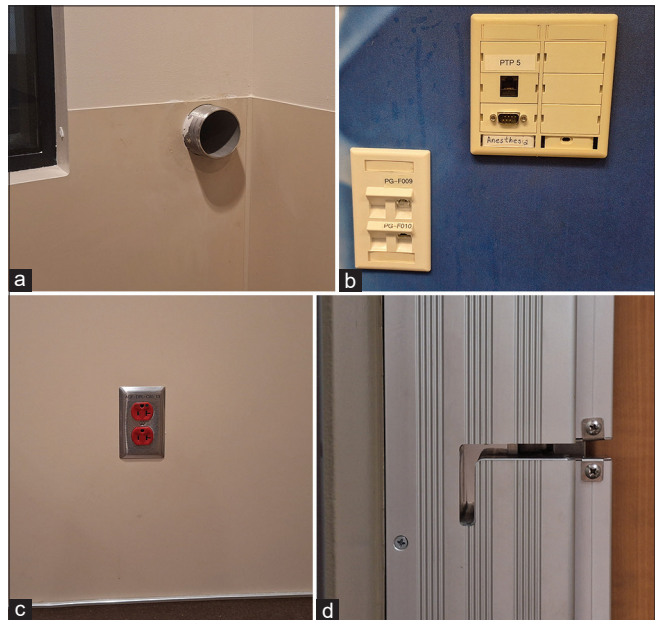
Figure 3: Photographs of (a) waveguide, (b) electrically filtered ports, (c) power outlets inside the magnetic resonance scanner room, and (d) a notch for passing non-metallic tubing.

Waveguide [Table 1] is a device commonly installed in a MR scanner room to allow the passage of fiber optic cables and hoses for pneumatic or hydraulic system to the control room [Figure 3a]. It is, however, not intended for the passage of electrically conductive objects, such as electrical cable or power cord, which can introduce unwanted RF field into the scanner room. For electrical cable or power cord, RF electrical filtered port/outlet should be used instead [Figure 3b and c]. In recent years, some newer MRI rooms are designed with a notch by the side of the scanner room door [Figure 3d] to allow small non-metallic tubing such as intravenous lines to conveniently pass through without resorting to the waveguide that takes more time and effort to use.

artifact was caused by an MR-conditional movable lamp [Figure 4b] positioned near the scanner table to provide better lighting for MR-assisted biopsy procedure. The artifact appeared when the power cord of the lamp was connected to an outlet in the control room through the waveguide of the scanner room [Figure 3a], and the problem persisted even when the lamp was turned off [Figure 4c]. However, the artifact was eliminated once the power cord was pulled back completely inside the scanner room [Figure 4d].

In another patient MRI examination, RF interference artifact was observed in the abdomen images [Figure 5a]. The artifact was found to stem from an internet cable connecting an anesthesia machine [Figure 5b] in the scanner room to a computer in the control room through the waveguide [Figure 3a]. The artifact problem was resolved by first connecting the internet cable from the anesthesia machine to an electrically filtered port inside the MR scanner room [Figure 3b] and then to the computer using another internet cable plugged into the port on the other side of the wall in the control room [Figure 5c].

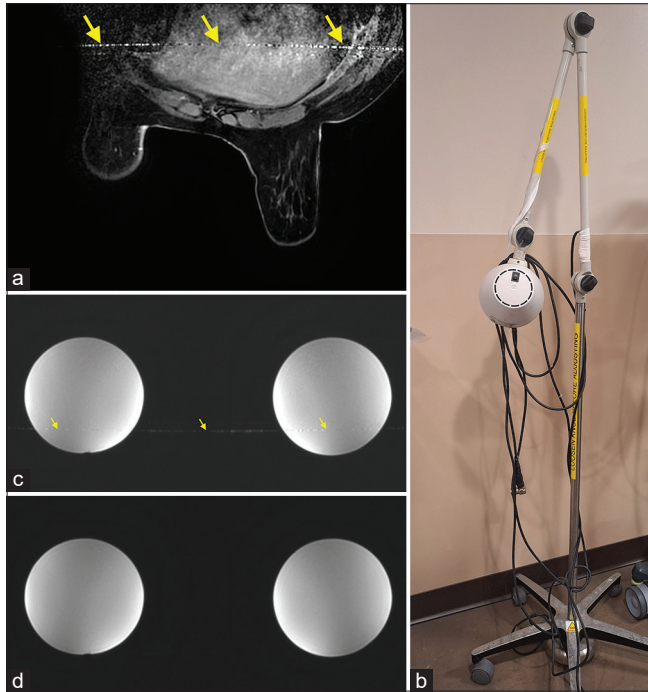
Figure 4: (a) A breast image with radiofrequency interference artifact (yellow arrows) caused by (b) a lamp inside the magnetic resonance (MR) scanner room with the power cord fed through the waveguide and connected to a power outlet in the control room. Phantom testing verified that the (c) artifact (yellow arrows) was caused by the power cord and (d) the artifact was eliminated after the power cord was pulled back completely into the MR scanner room.

Figure 4a shows RF interference artifact appeared in a breast MRI examination. The MR technologists involved in the examination recognized the image artifact as being related to RF interference but failed to identify the source. Subsequent phantom testing by a site MRI physicist revealed that the

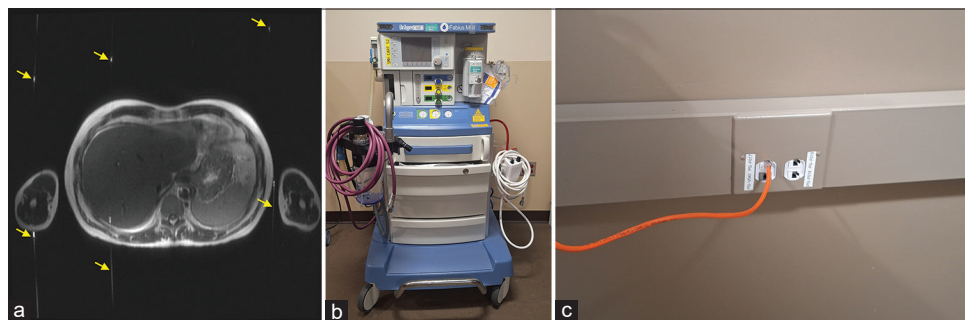
Figure 5: (a) Abdomen magnetic resonance (MR) image with radiofrequency interference artifact (labeled by yellow arrows) caused by (b) an anesthesia machine in the MR scanner room. External radiofrequency field was introduced into the MR scanner room through an internet cable connected to a computer in the control room through the waveguide, leading to the artifact. The artifact problem was solved by first connecting the internet cable from the anesthesia machine to an electrically filtered port inside the MR scanner room and then to the computer using another internet cable plugged into (c) the port on the other side of the wall in the control room.

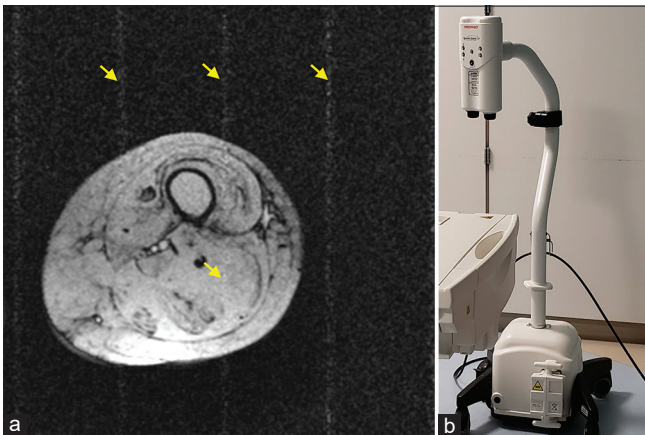
Figure 6: (a) Radiofrequency interference artifact (labeled by yellow arrows) on a leg magnetic resonance (MR) image caused by (b) a power injector inside the MR scan room.

Equipment inside the MR scanner room, such as patient-supporting equipment, may also be a source of RF interference. An example is a case of leg MRI acquired using an extremity RF coil [Figure 6a]. At first, the MR technologist thought that the image artifact was caused by the extremity coil since the artifact was not observed when she switched to use the scanner body coil for the MRI exam.^[11] However, later investigation by an MRI physicist discovered that the artifact was actually caused by a power injector inside the room [Figure 6b]. Phantom testing showed that the artifact was present on images obtained by the extremity coil when the power injector was plugged to an outlet inside the scanner room, regardless of whether the injector was turned on or

off. However, the artifact disappeared when the injector was unplugged from the power outlet. The fact that the artifact was not observed with the body coil earlier was due to low-signal sensitivity of the body coil, resulting in the RF artifact hidden in the background noise.

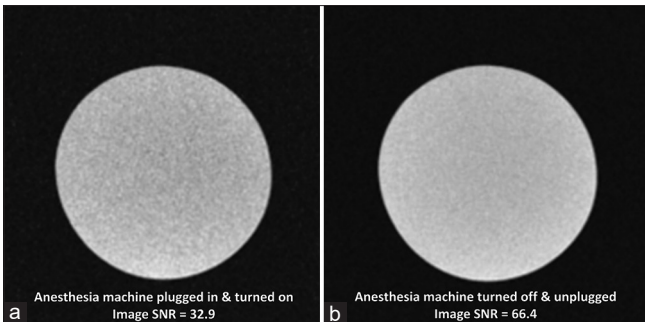
Figure 7: Phantom testing showed (a) image signal-to-noise ratio was lower when an anesthesia machine positioned near the magnet was plugged into a wall outlet inside the magnetic resonance scanner room and turned on compared to (b) image signal-to-noise ratio after the anesthesia machine was turned off and unplugged.

Besides line/band artifacts, equipment inside the MR scanner room may generate very broadband noise that increases image background noise, leading to lower SNR and lower image quality.^[6] In an investigation of poor image quality problem in an MRI system, it was found that an anesthesia machine positioned near the magnet was the cause of the problem. Phantom testing showed image SNR reduced from 64.4 to 32.9 when the anesthesia machine was plugged into an outlet inside the MR scanner room and turned on [Figure 7a and b].

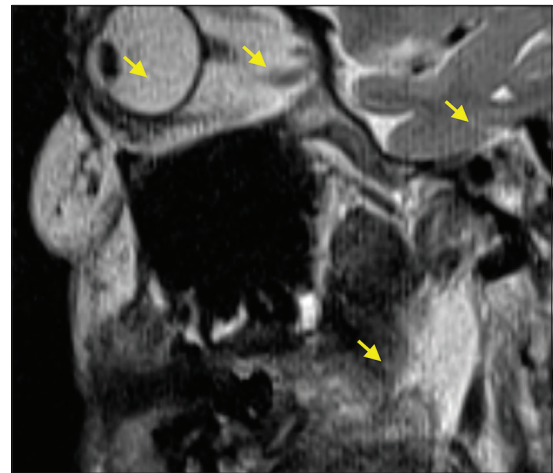
Figure 8: Head magnetic resonance image showing spike artifact (labeled by yellow arrows) across the whole image.

Spike artifact, also called Herringbone artifact, crisscross artifact, or corduroy artifact, originates from electrical charge interference and appears as parallel bright and dark straight lines across the entire image [Figure 8].^[1,3,4,7] It can be caused by a discharge of static electricity in the receiver, which may be a result of low humidity, or there may be defective or loose components in the RF circuitry. Besides, magnetic field gradients [Table 1] may also produce spikes, especially when

applied at a very high-duty cycle. Unlike the RF artifact, the lines of the artifact can be in an orthogonal direction or at an oblique angle, with the orientation and separation of the lines depending on the position of the spike in the k-space data. Another difference from RF interference is that spike artifact is usually sporadic and limits to one or two images in a series while RF interference artifact tends to appear in all images within a series.^[7]

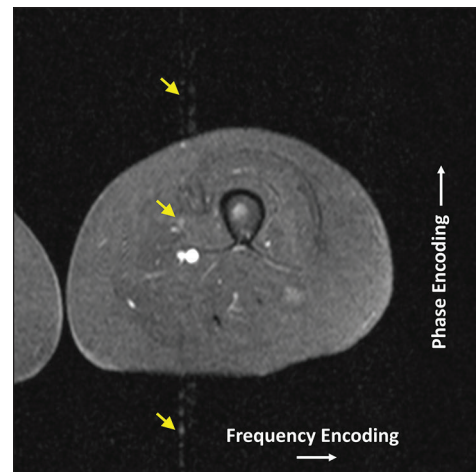
Figure 9: Leg magnetic resonance image with pulsation blood flow artifact (labeled by yellow arrows). Note the artifacts are in line with the blood vessels in the phase encoding direction.

Body tissue motion or fluid flow during an MR scan can produce image artifacts that manifest along the phase-encoding direction and extend over the entire image [Figure 9].^[1-9,12] Motion artifacts may stem from blood vessel pulsations, respiratory/cardiac motion, swallowing, and physical movement of the patient. Random motion such as patient movement tends to produce artifact that has a smear appearance while periodic motion, such as cardiac/vascular pulsation or respiratory motion, typically produces artifacts that are more discrete. Motion artifact may be identified and distinguished from RF interference artifact by observing that the artifact is in line with the moving tissues or flowing vessels in the phase-encoding direction [Figure 9].

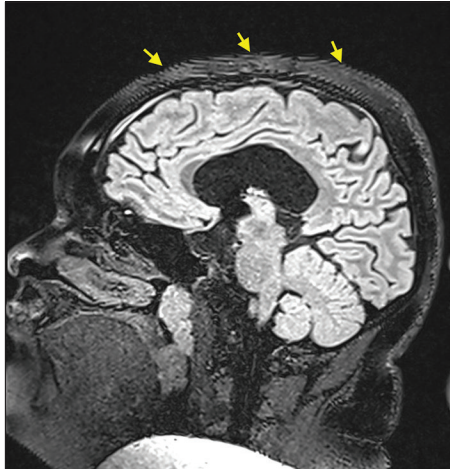
Figure 10: Free induction decay artifact (labeled by yellow arrows) in the subcutaneous fat on top of the head fast-spin-echo magnetic resonance image.

Free induction decay (FID) [Table 1] artifact appears as an intensity ripple, as seen in the subcutaneous fat at the top of the head in this 3D fast spin-echo (FSE) [Table 1] image [Figure 10]. This artifact is caused by the formation of FID signal from non-180° refocusing RF pulses [Table 1] that are typically used in 3D FSE sequences.^[1,13] The FID signal creates an image containing only the edges of tissues with
